CENTRAL MINING COMPANY CLERK'S HOUSE  
Central Mine Historic District  
Main East-West road  
Central  
Keweenaw County  
Michigan

HABS MI-420  
*MI-420*

**HISTORIC AMERICAN BUILDINGS SURVEY**  
**CENTRAL MINING COMPANY CLERK'S HOUSE**

**HABS No. MI-420**

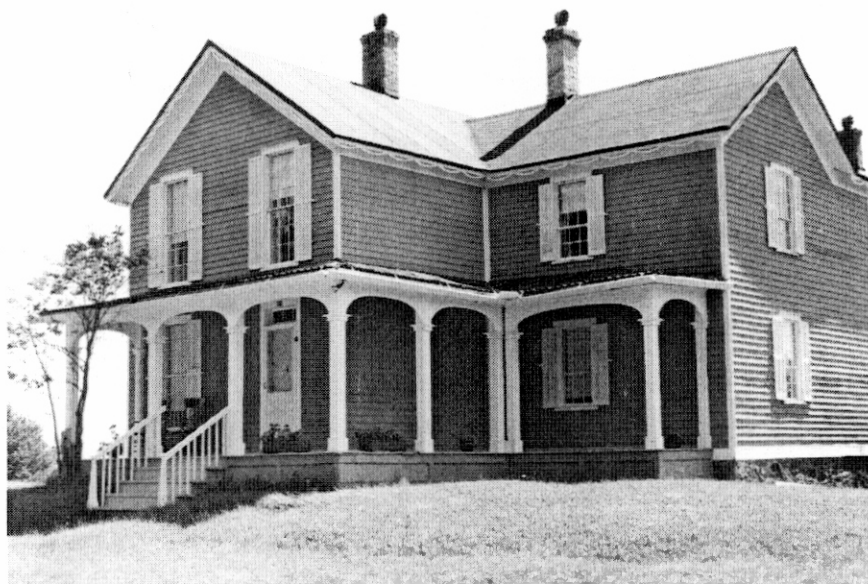
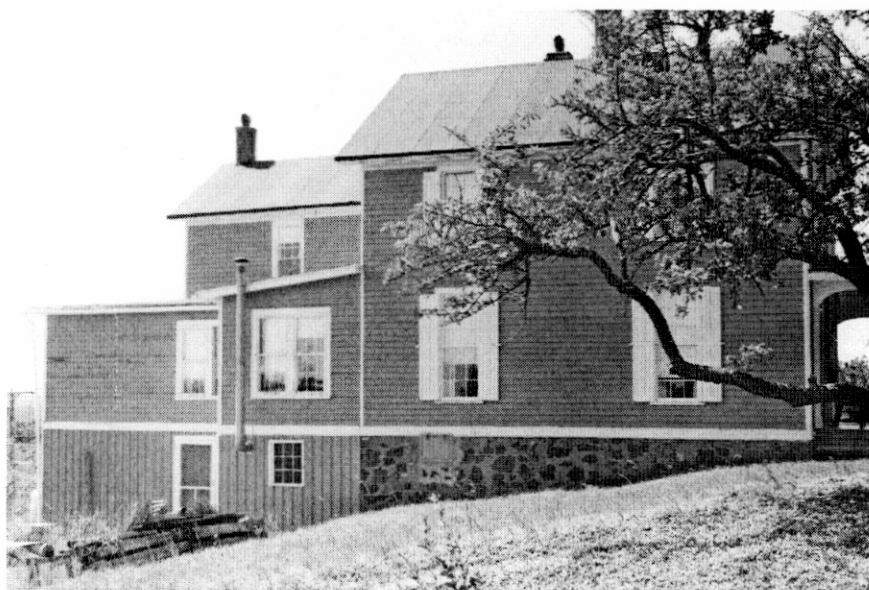
1. Architectural character: The Central Mining Company Clerk's House is one of approximately twenty remaining dwellings at the Central Mine location. A much added-to frame house, it is the house to which the mining company clerk was assigned. Lacking any distinctive architectural detail, it remains a well-preserved structure of simple design (fig. 1).
2. Condition of fabric: Excellent.

Fig. 1 Perspective view. Photo by author, 1975.

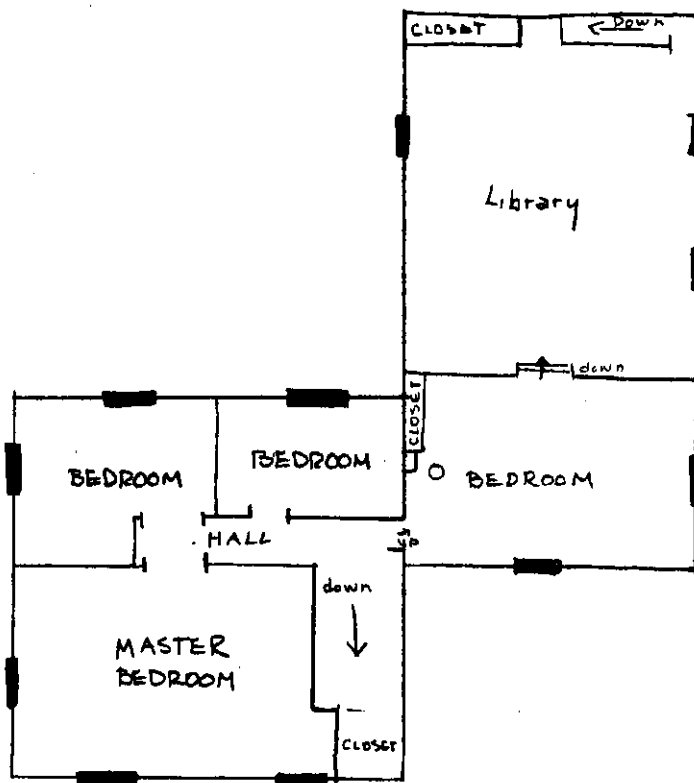
CENTRAL MINING COMPANY CLERK'S HOUSE  
SECOND FLOOR PLAN

Fig. 4 Floor plan of second floor. Drawing by author, 1975.

1. Floor plans: The front door opens into a narrow stairhall with a single flight stair along the west wall of the northeast gable section. Two parlors lie to the east and south of the entrance hall. The dining room, kitchen, pantry, back stair and outhouse line the west wall of the building, encompassing the western half of the dwelling. A recent sunroom, modern bathroom, and stairway to the cellar occupy the additions to the back of the northeast gabled section. The second floor can be reached from either the front or back staircase. In the northeast gabled section are three small bedrooms to off a central hall. One steps down into the master bedroom which is above the dining room in the northwest gabled section of the house. To the south of the master bedroom is a large open library. The back stairs connect the library with the kitchen below it. The basement is excavated except underneath the dining room and outhouse. Masonry walls divide the space much as it is divided on the first floor, reflecting the stages of construction (figs. 2-4).
